HISTORIC BUILDING RECORD FOR GLEBE BARN,  
BRIGHTLING  
ARCHAEOLOGY SERVICES LEWES  
Report number: ASL 45-14  
November 2014

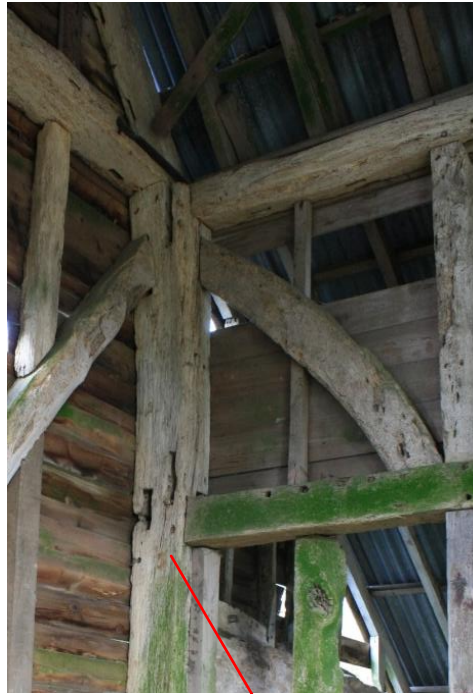
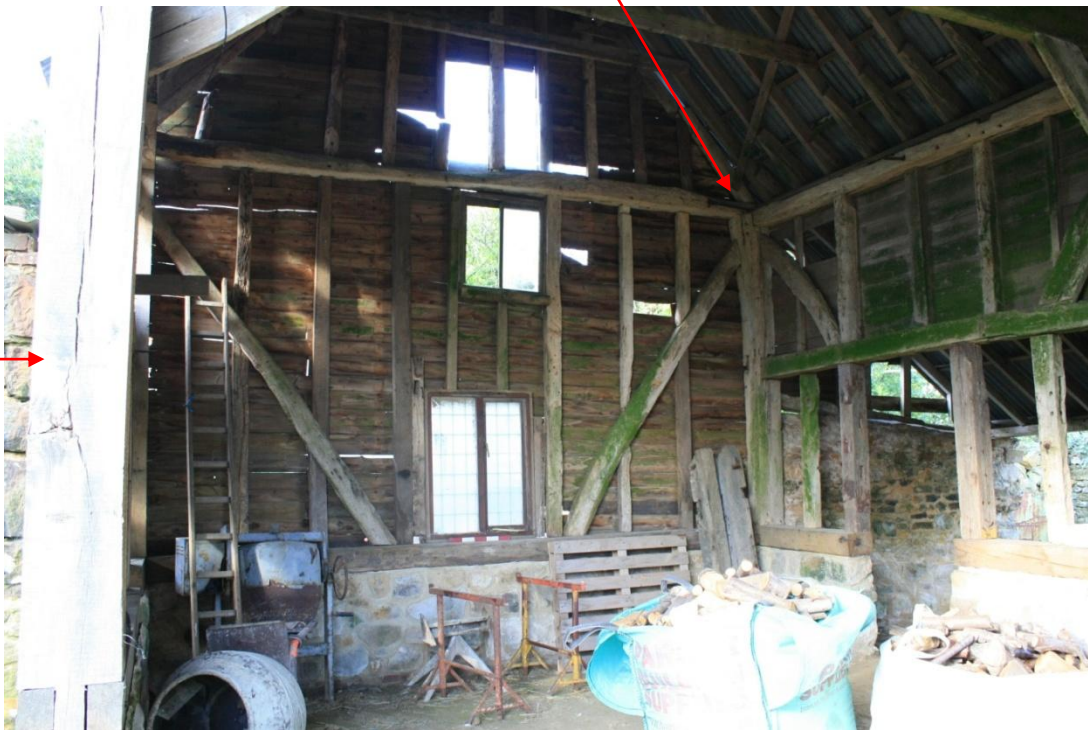
Plate 2 and 3 west elevation truss A

5.2.2 At truss A the principal post measures 220mm wide and has a slightly sloping jowl to the top (plates 2 and 3). Mortices cut into the south facing side are indicators of its previous use and do not connect to the current building.

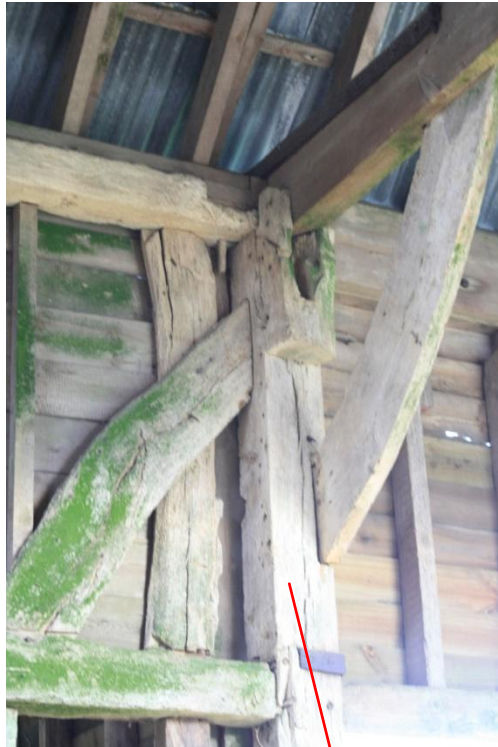
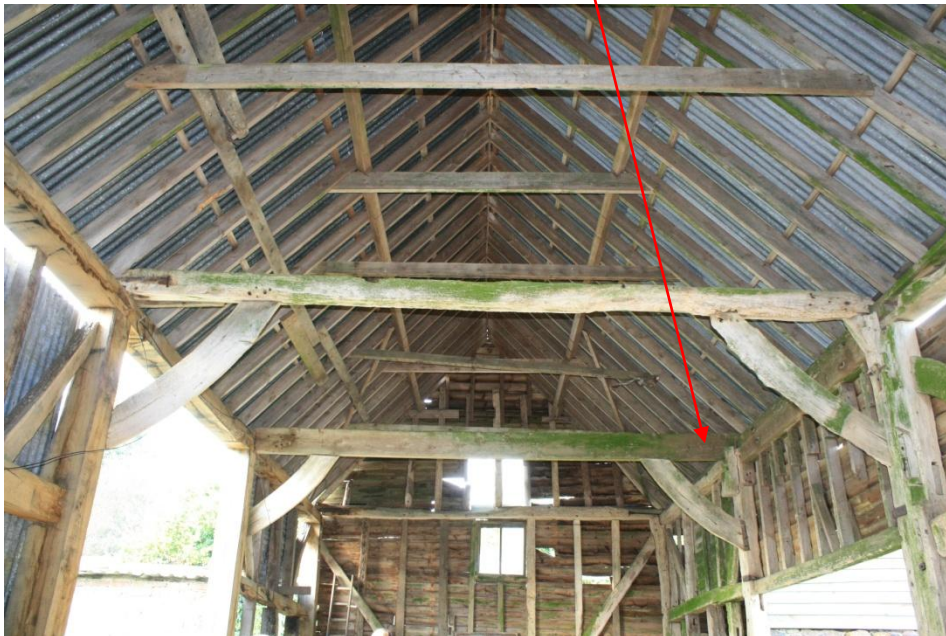
Plate 4 and 5 truss B principal post

5.2.3 At truss B the northern principal post has a stepped jowl (plates 4 and 5) and is 190mm wide and a convex curved head brace running to the modern tie-beam.

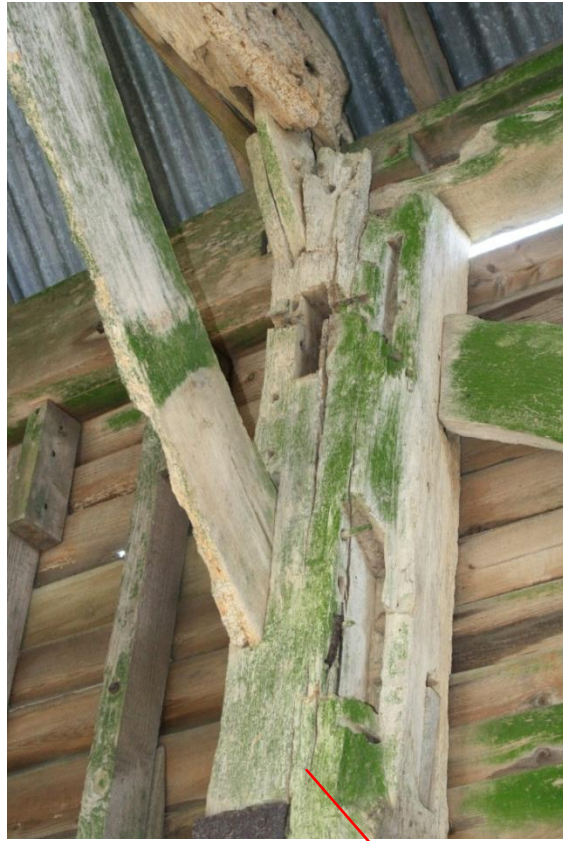
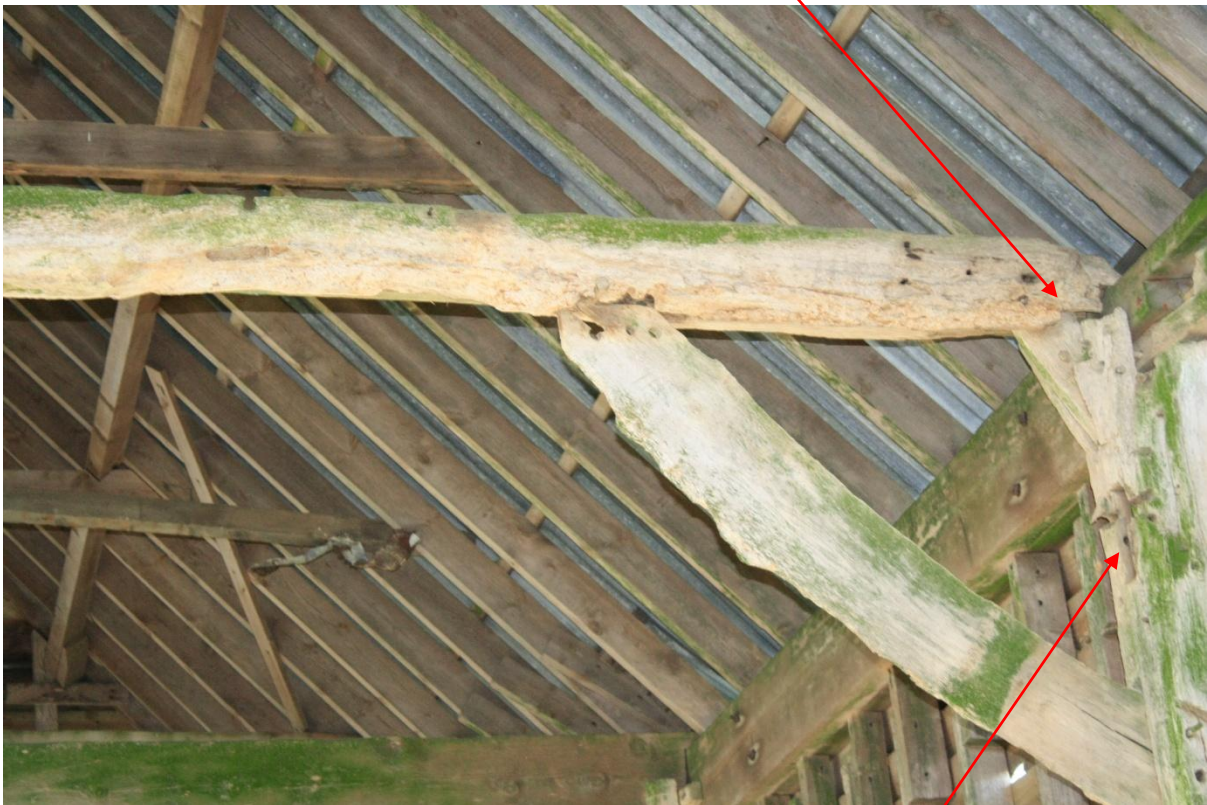
Plate 6 and 7 truss C principal post

Former shore  
ran to mortice

- 5.2.4 The post at truss C is 260mm wide and also has a sloping jowl has been compromised by the truncation of the top of this post to fit it into the frame height (plate 6 and 7). This truss has been recorded by a cross section drawing (fig.9).The brace has evidence for a removed shore, which was mirrored in truss B, which would have run diagonally down to the soleplate with a rail fixed between the shore in truss B and C in order to facilitate crop storage. This post in particular has been open to the elements for some time and has been subjected to fairly extensive weathering and is in a very poor condition. There is a convex curved head brace running to the tie-beam. Further mortices in the south face relate to a previous phase. The external face of this post was visible during a recent watching brief (Fisher, L 2015. A Watching Brief at Glebe Barn, Brightling. Project number ASL 45-14) which showed two further mortices cut into the east facing side.

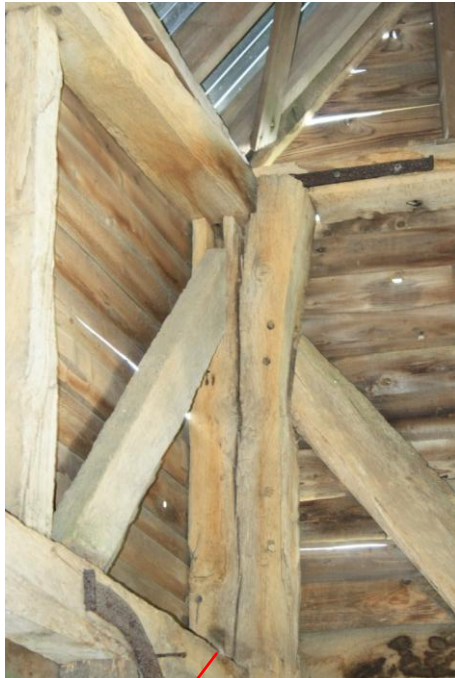
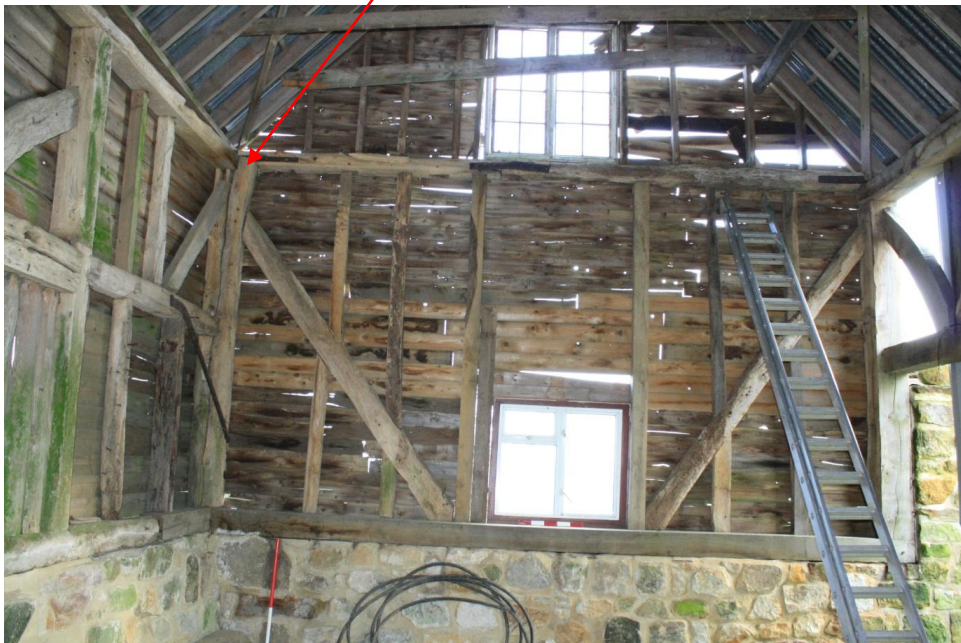
Plate 8 and 9 Truss D and the principal post

- 5.2.5 The last principal post in truss D has been compromised by the truncation of the top of this post to fit it into the frame height. The width of this post is 240mm.
- 5.2.6 The plinth on which the frame sits is a yellow sandstone, most likely of local derivation from the Ashdown formation beds which the barn is situated on, but has recently been re-built. Towards the rear elevation, the half height doorway has now been filled in between truss B and C to create a continuous plinth at this point.

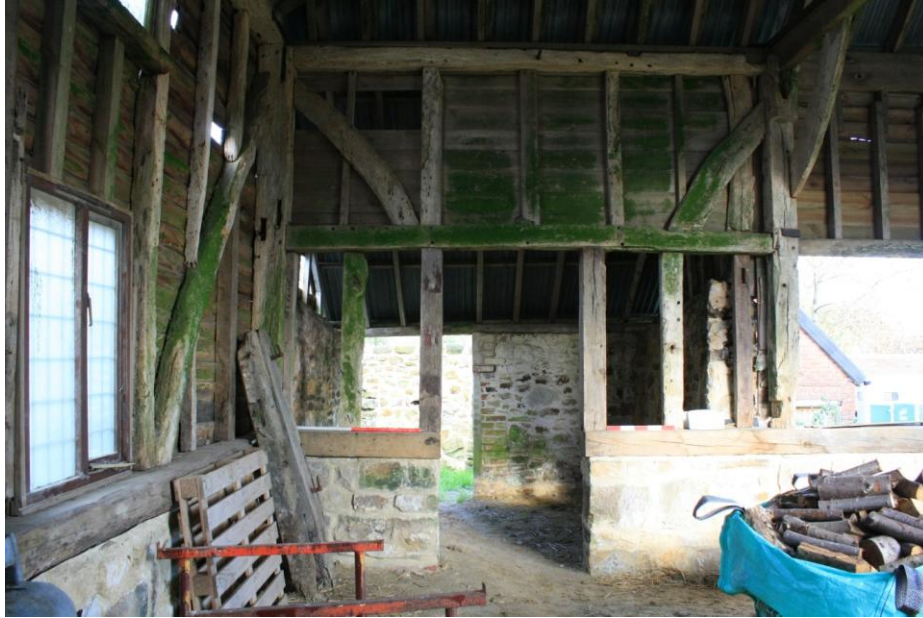
Plate 10. The north elevation between truss A and B with outshot beyond (scales 1m and 50cm)

- 5.3.3 The north elevation between truss A and B (plate 10 and 11) consists of re-used timbers of fairly thick scantlings at times with interrupted studs and curved braces 190mm wide which run from the wall plate to the side girt. This elevation has been recorded by a long section drawing (fig 9). The wall plate and the side girt have mortices cut into the soffits indicating the position of previous timbers and in particular, the wall plate has stave holes to the side of some of the mortices indicating a previous wattle and daub exterior which does not belong to this structure. The elevation between truss B and C houses the wagon way and between truss C and D (plate 12) a similar construction design utilizes older timbers of similar scantlings with interrupted studs and corner bracing but with an intermediate post approximately two thirds of the way across the bay to the east.

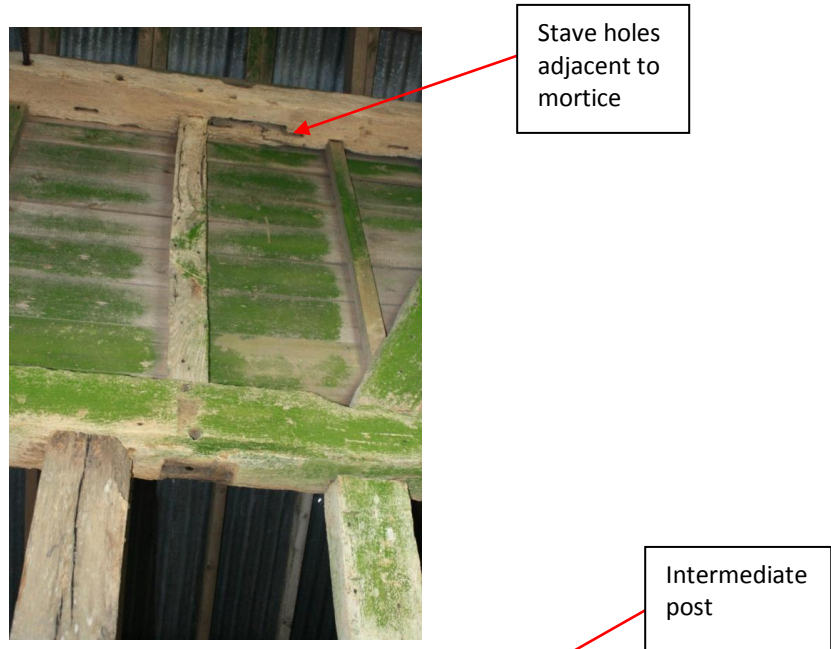
Plate 11 mortices in soffit of north wall plate between truss A and B with adjacent stave holes

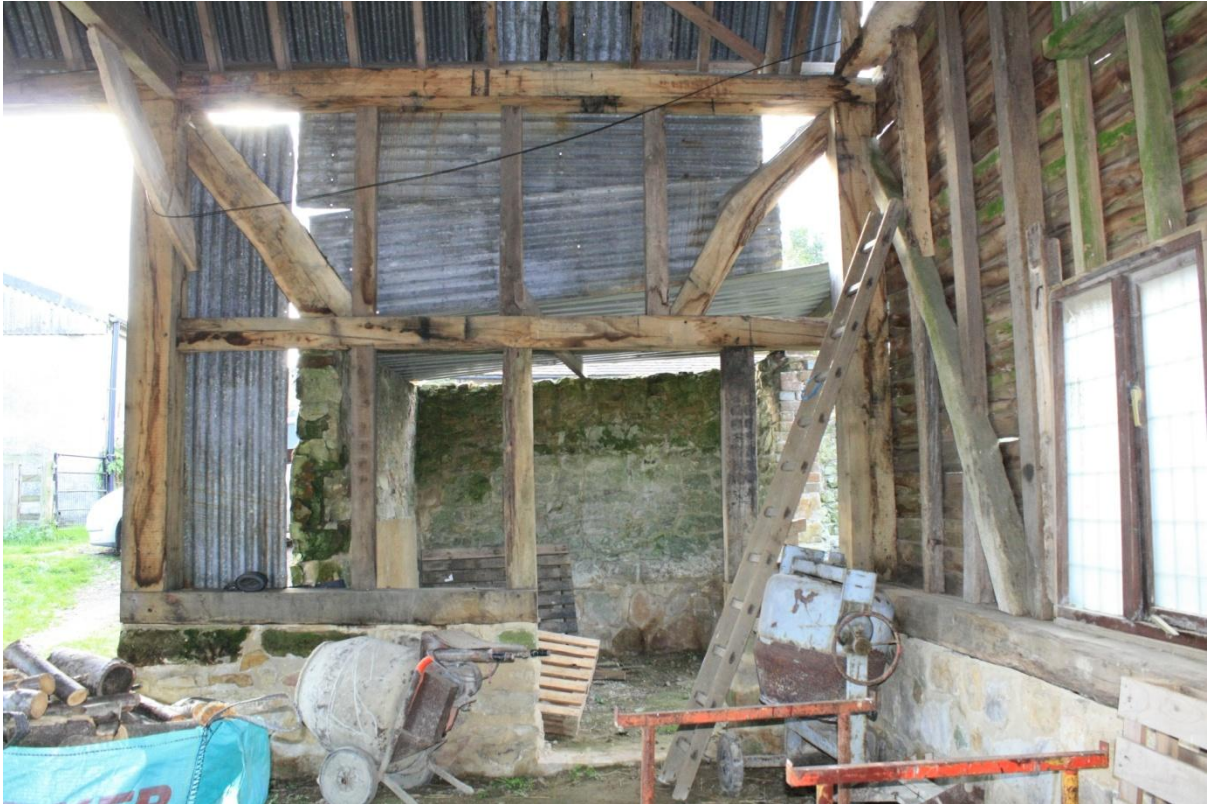
Plate 13 Re-built south elevation between truss A and B

- 5.3 The wall designs
- 5.3.1 Only three elevations can be described and recorded due to the fact that in very recent years, the barn was in imminent danger of collapse and the whole building has been subjected to fairly extensive renovations in order to make the structure safe. This included jacking the walls up to re-build the collapsing sandstone plinth as well as completely re-building the front (southern) elevation out of green oak. Whilst this has been done to a very good standard matching the old frame (most likely) with like for like, it cannot be taken as an absolute. However, photographs are evident before renovation works were carried out which show the 'original' structure to be very similar (see appendix).

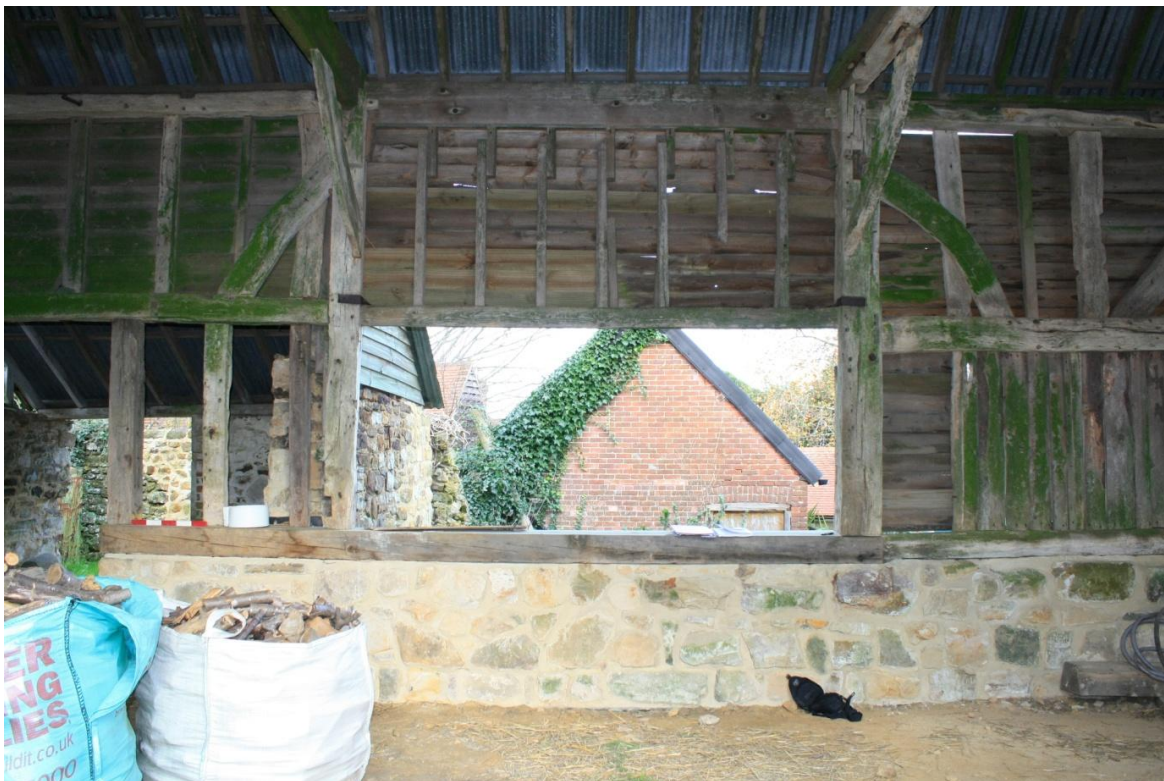
the side girts. However, the same problem occurs in that as these are re-used timbers it is impossible to say for certain and the existing rail may be original to the build. The sandstone plinth underneath this half height door is a modern addition as is the sole plate (plate 16 and 17).

Plate 17 Half height entrance with new plinth built between truss B and C

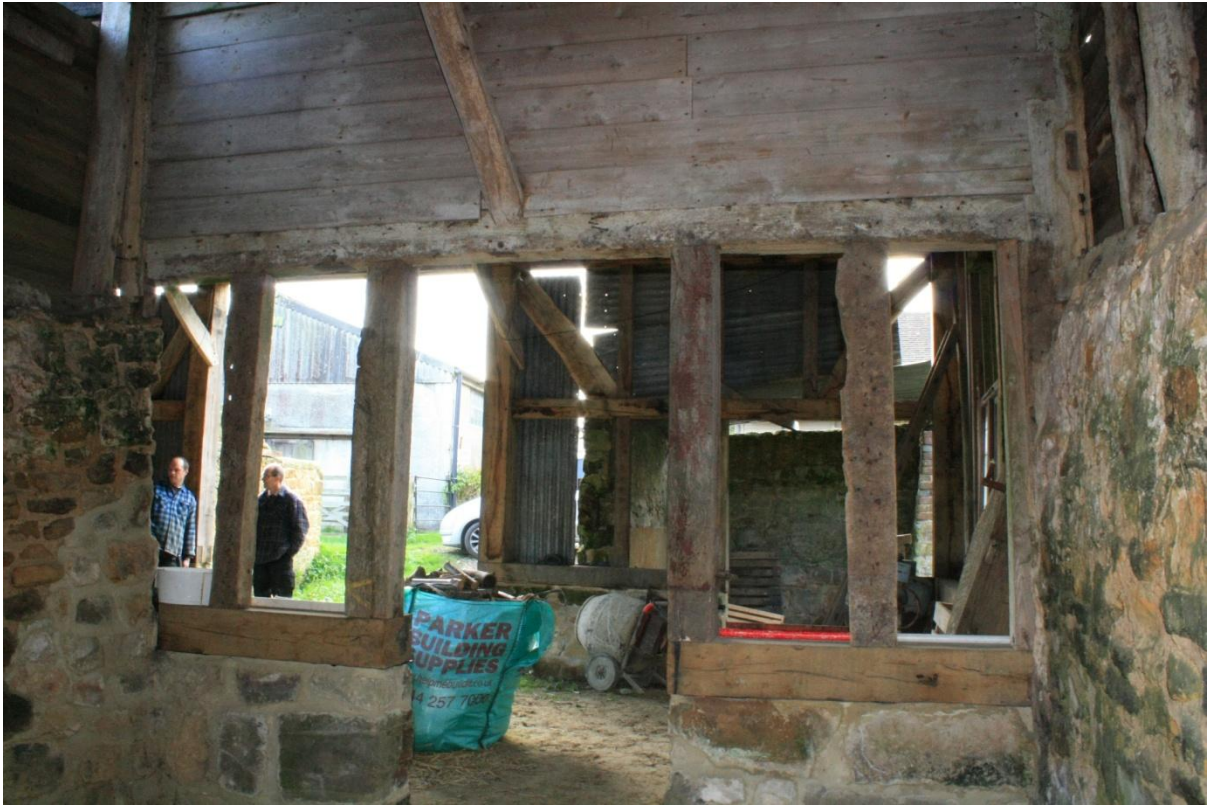
Plate 19 The replaced plinth and sole plate of the north west outshot

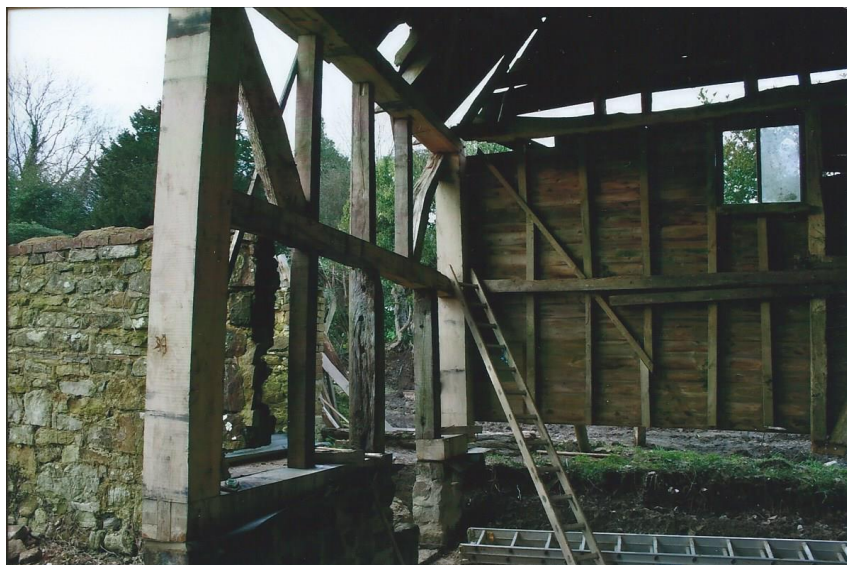
Shore, feeding rack and inserted (?) floor dismantled prior to survey

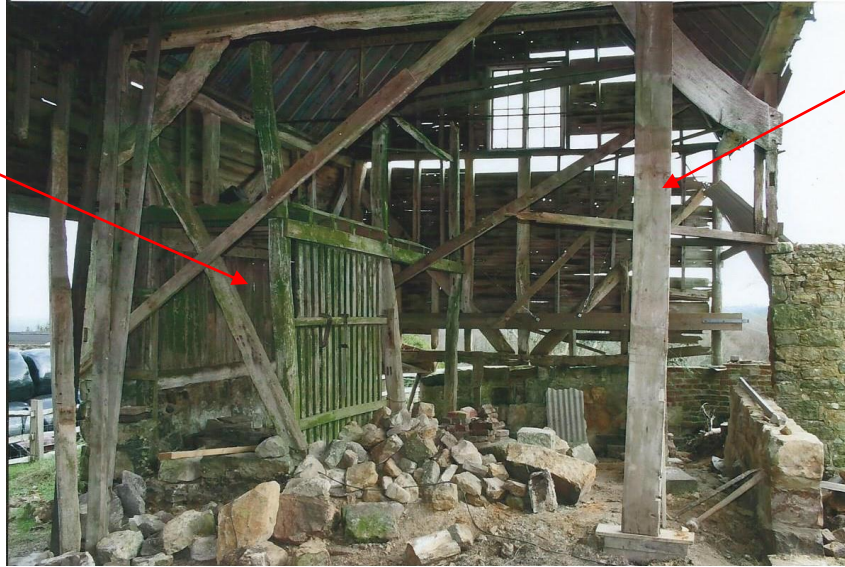
Plate 23 Looking east (Reproduced by kind permission of Jamie French)

Inserted post demarcates the line of the internal wall with previously attached shore

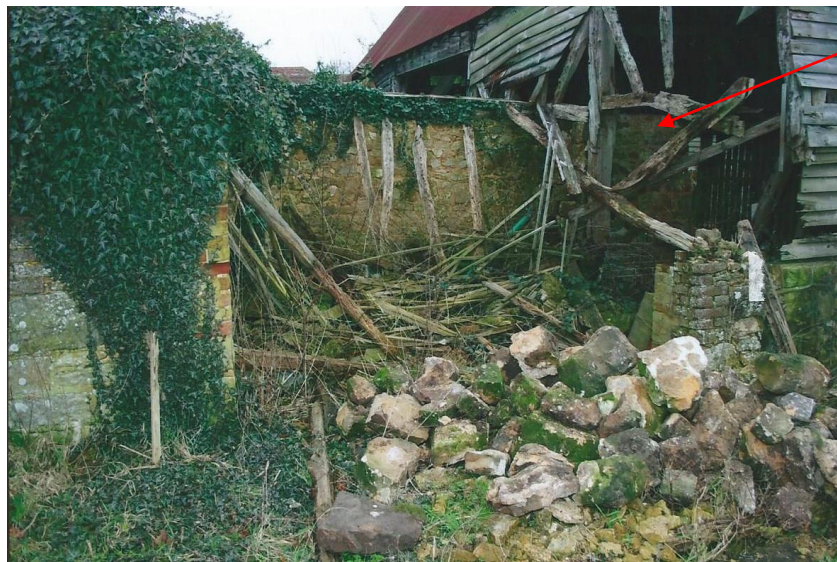
Plate 26 Before renovating the south east corner (Reproduced by kind permission of Jamie French)

Inset wall  
to south  
elevation

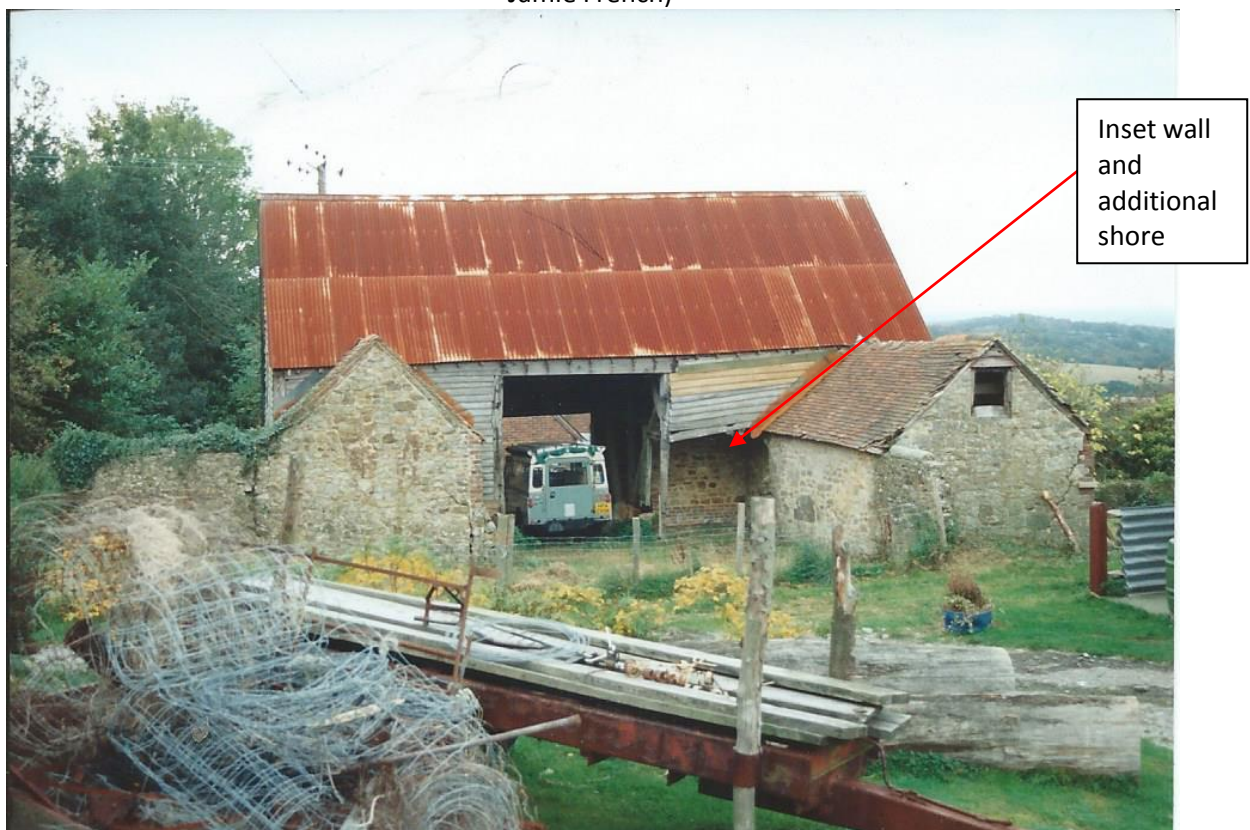
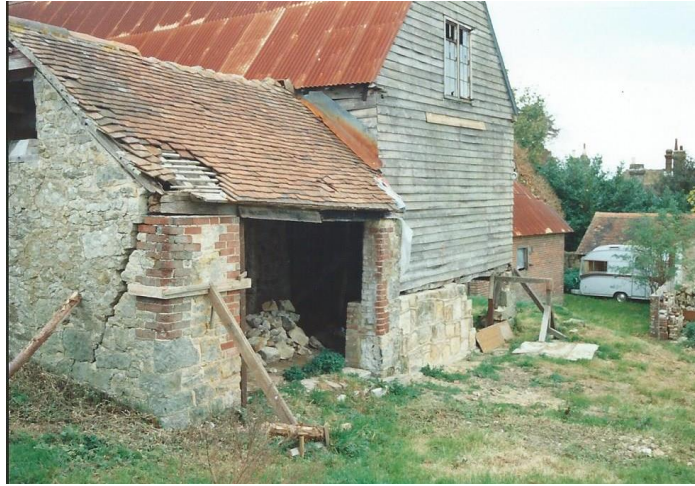
clients photographs taken before this wall was removed (plate 35 and 36). There appears to be an inserted sandstone wall which is inside the building at least one meter to the north of the south elevation. This appears to run between truss C and D but possibly with a doorway enabling access to the south east outshot and appears to be higher than the side girt. There also appears to be another shore extending down from the principal post at truss C towards the floor (plate 35 and 36).
