HISTORIC BUILDING RECORD FOR GLEBE BARN,  
BRIGHTLING  
ARCHAEOLOGY SERVICES LEWES  
Report number: ASL 45-14  
November 2014

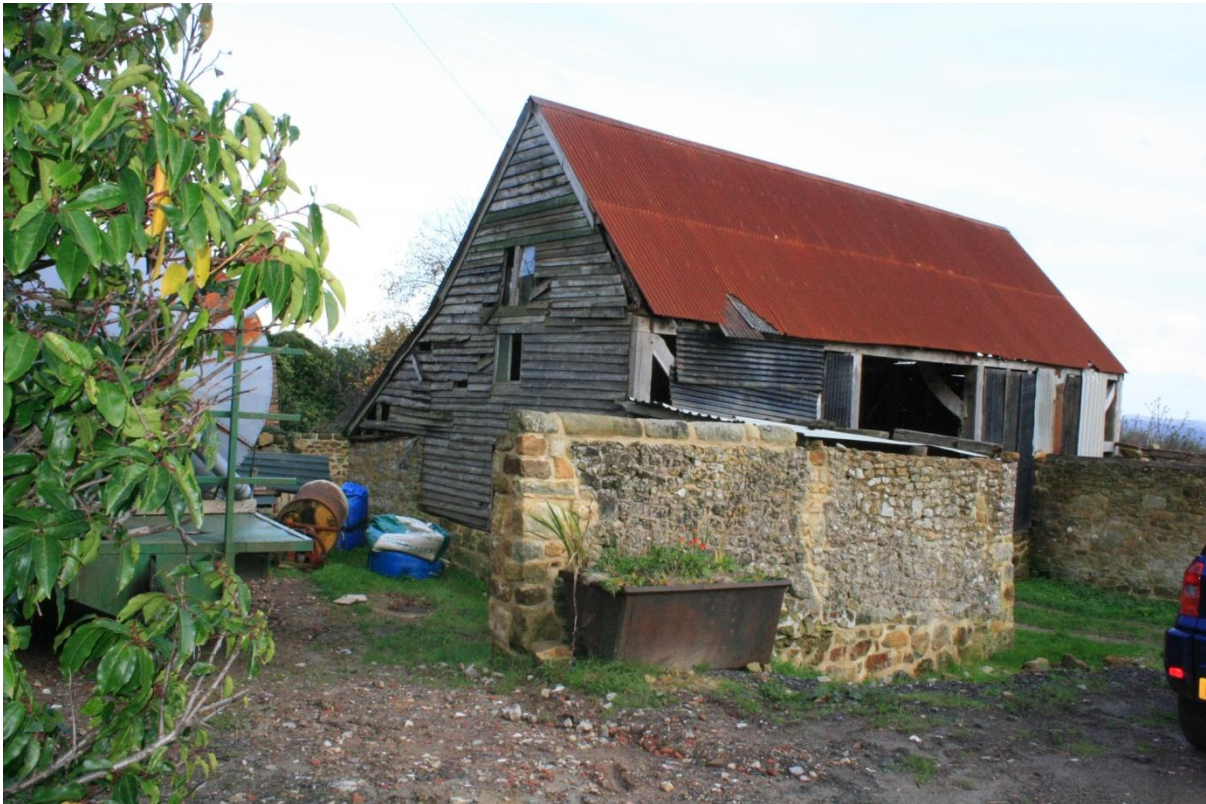
- 4.1 The barn is a standard three bay crop storage barn (plate 1) measuring 12.18m x 5.12m with a wider bay at the east side measuring 5.20m in comparison to the smaller bays which measure 3.6m. It is likely that it once had a threshing floor in the middle although the floor area has been reduced prior to the survey. The barn is made from re-used timbers, possibly from an earlier barn that existed nearby, but there would appear to have been several incarnations of buildings constructed on site either on the current footprint or near to it as laid out below. The first mention of a barn being built has previously been discussed (in 2.2 above) where two barns were brought to the site in 1665 to construct a new one. It is highly likely that the re-used barns were then used to build a new barn, to the west of the existing site as evidenced by the maps from 1710. It was initially thought that the existing structure dated to the mid 18th century, based on the structural style rather than the scantlings and architectural style of the timbers used. However, it became clear during the map regression that the barn had ceased to exist on its former site in the 18th century and a new one erected in the mid 19th century. It is highly likely, although not proven, that this 'new' barn was erected utilizing the demolished timbers from the previous structure, which in itself was recycled dating from the 17th century, if not earlier. This did not aid clear interpretation; the dating of the barn is therefore based on the map evidence alone, rather than the structural style of the timbers or architectural elements such as types of principal posts and the scantling of the timbers used in the construction. Based on such observations, the barn can be dated fairly confidently to the early 19th century [**Period A**] and certainly after 1838 when the barn is not registered on the tithe map for this date. There is large proportion of this earliest structure on this site remaining in the rear elevation as well as the two side elevations although they have suffered from rot over the years. This structure is aligned at right angles to the farm entrance.

Plate 1 the exterior of the barn from the farm entrance looking east

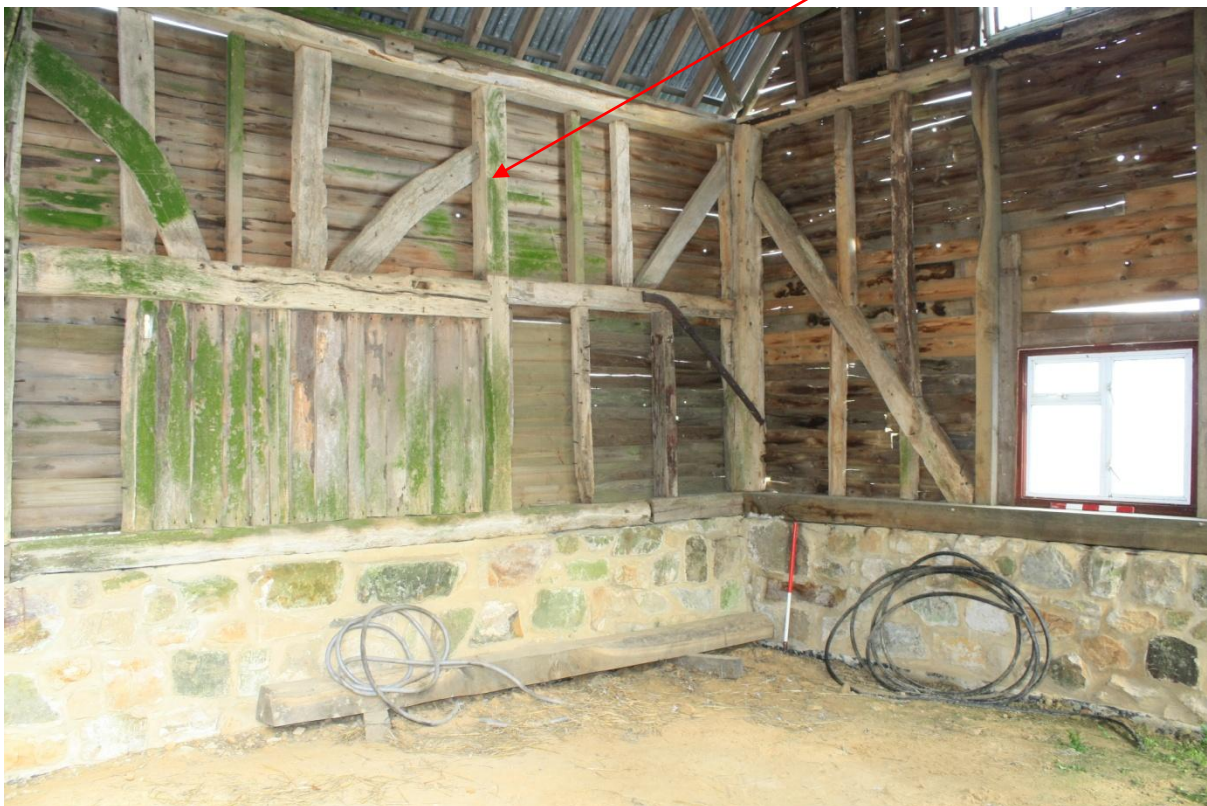
Plate 12 north elevation between truss C and D (scales 1m and 50cm)

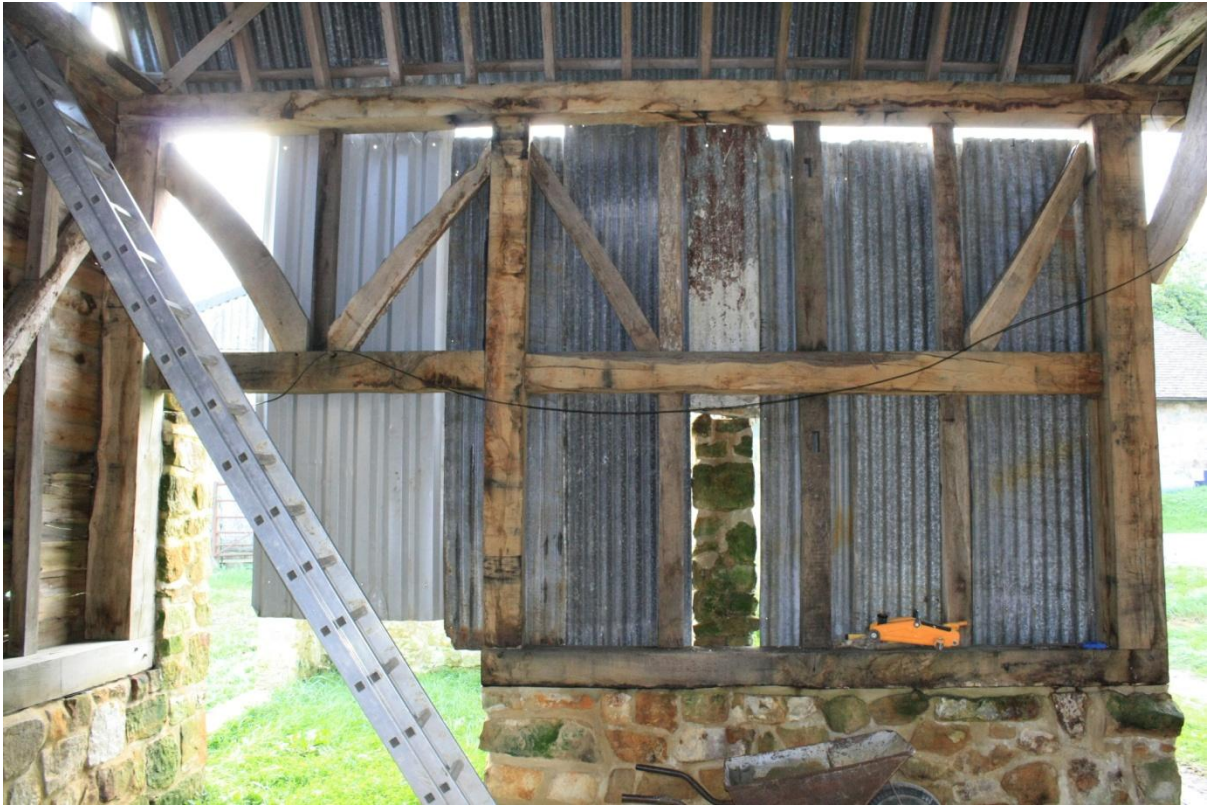
- 5.3.4 The east elevation consists of full length raking struts and interrupted studs.
- 5.3.5 The west elevation consists of full length raking struts and interrupted studs (plate 3) and has been recorded by a cross section drawing (fig 9).
- 5.3.4 The south elevation is a modern replacement and has only been recorded by photographs (Plate 13 and 14). However, a cursory note should be made following observations from the

Plate 14 Re-built elevation between truss C and D

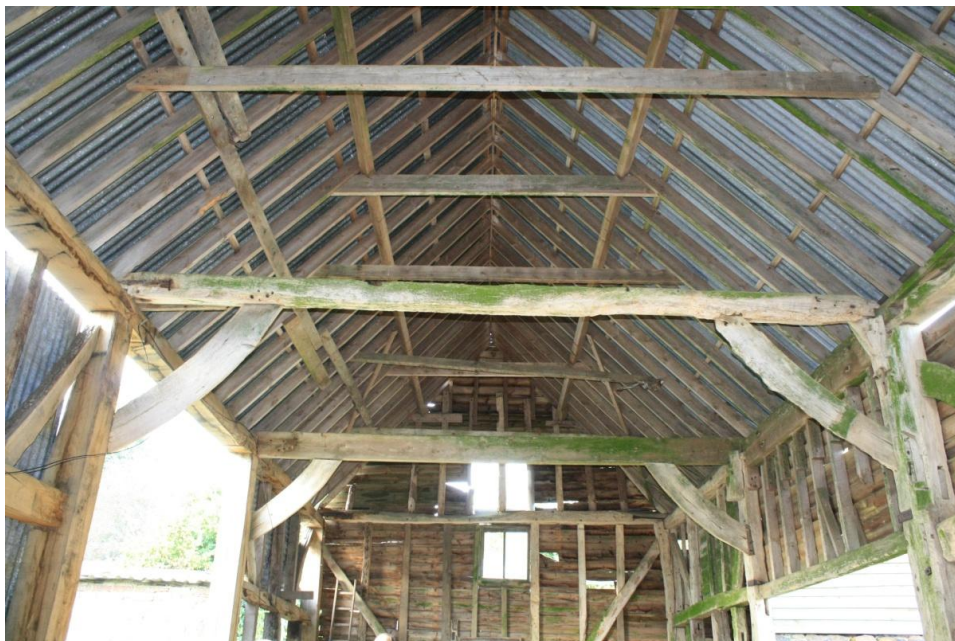
- 5.4.1 The current barn is built to a standard design with a full length entrance to the south and a half height entrance to the north (plate 15). The full height entrance is now a total re-build so cannot be commented on further.

Plate 15 Re-built full height entrance on left with half height door to the north

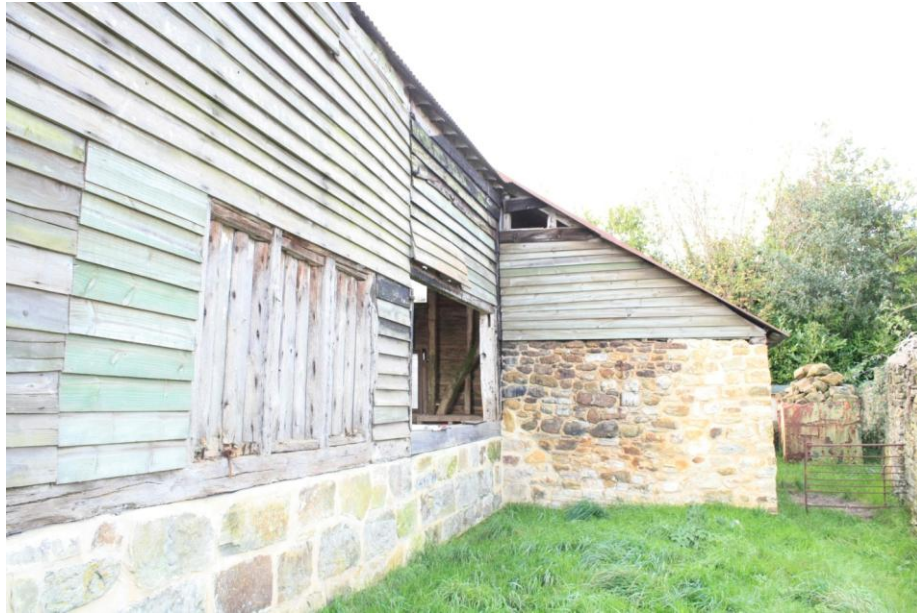
the side girts. However, the same problem occurs in that as these are re-used timbers it is impossible to say for certain and the existing rail may be original to the build. The sandstone plinth underneath this half height door is a modern addition as is the sole plate (plate 16 and 17).

Plate 16 Exterior shot of the half height entrance in the north elevation

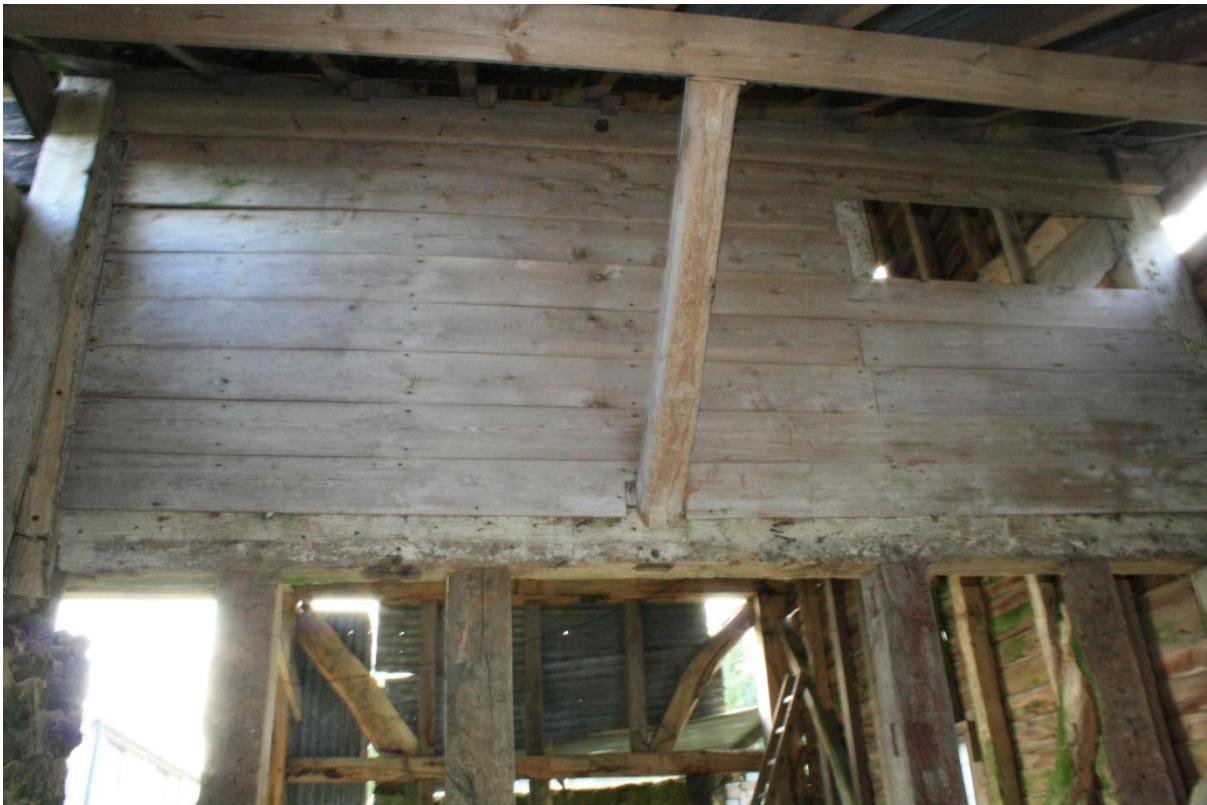
5.5.1 There are three additional outshots joined to the main structure to the north, south west and south east corners. Two additional outshots are present on earlier maps from 1874 (ESRO OS map 431) which shows a small outshot on the north east corner and a further one to the west elevation. Later maps show these still in existence up to 1930. These are not apparent now but the watching brief did uncover some brick laid areas which may relate to the former foundations for an outshot to the west elevation. These foundations were running parallel to the side of the barn but were not substantial and were not mortared in place. One of the clients photographs shot previously to renovations show a doorway in the north elevation at the northeast corner which would have given access to the small outshot in this location. Recent renovations have removed all traces of this doorway so it could not be recorded during the survey.

Plate 18 the outshot on the north elevation viewed from the north

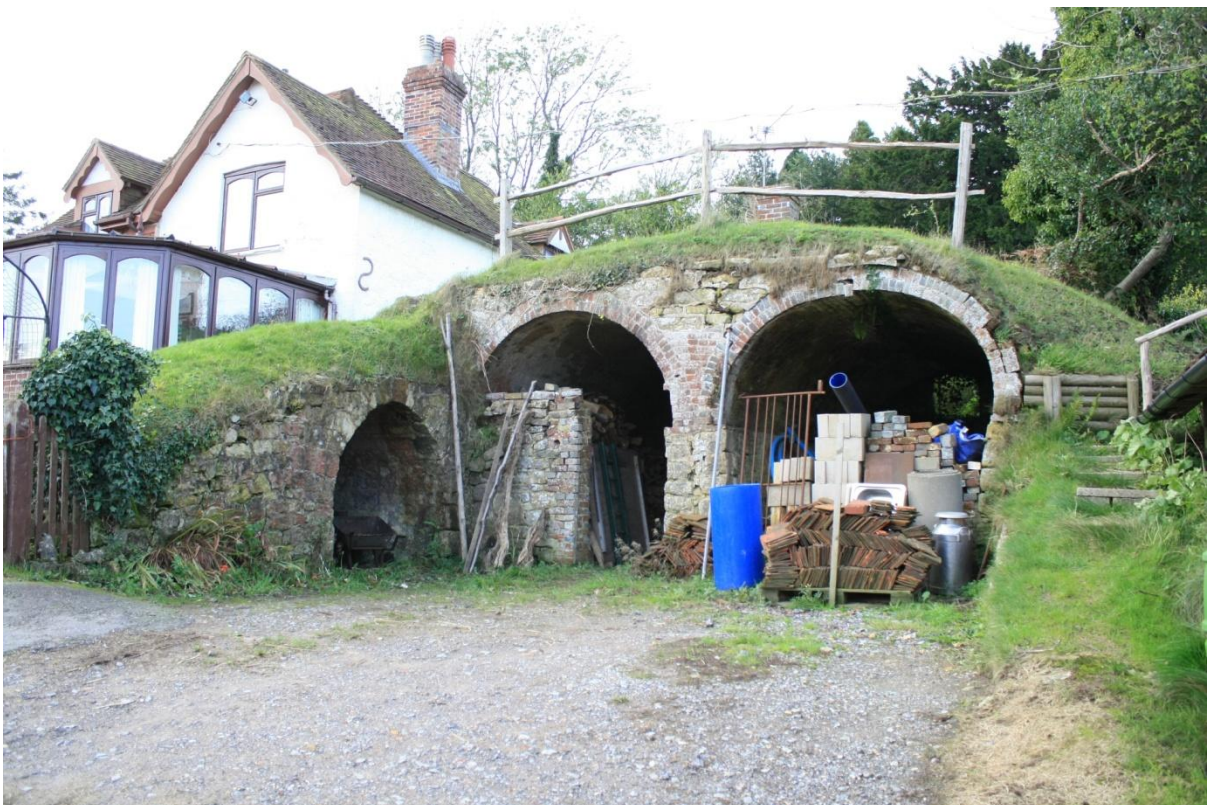
Plate 20. Curious structure built to the south of the barn, function unknown but potentially for lime burning.

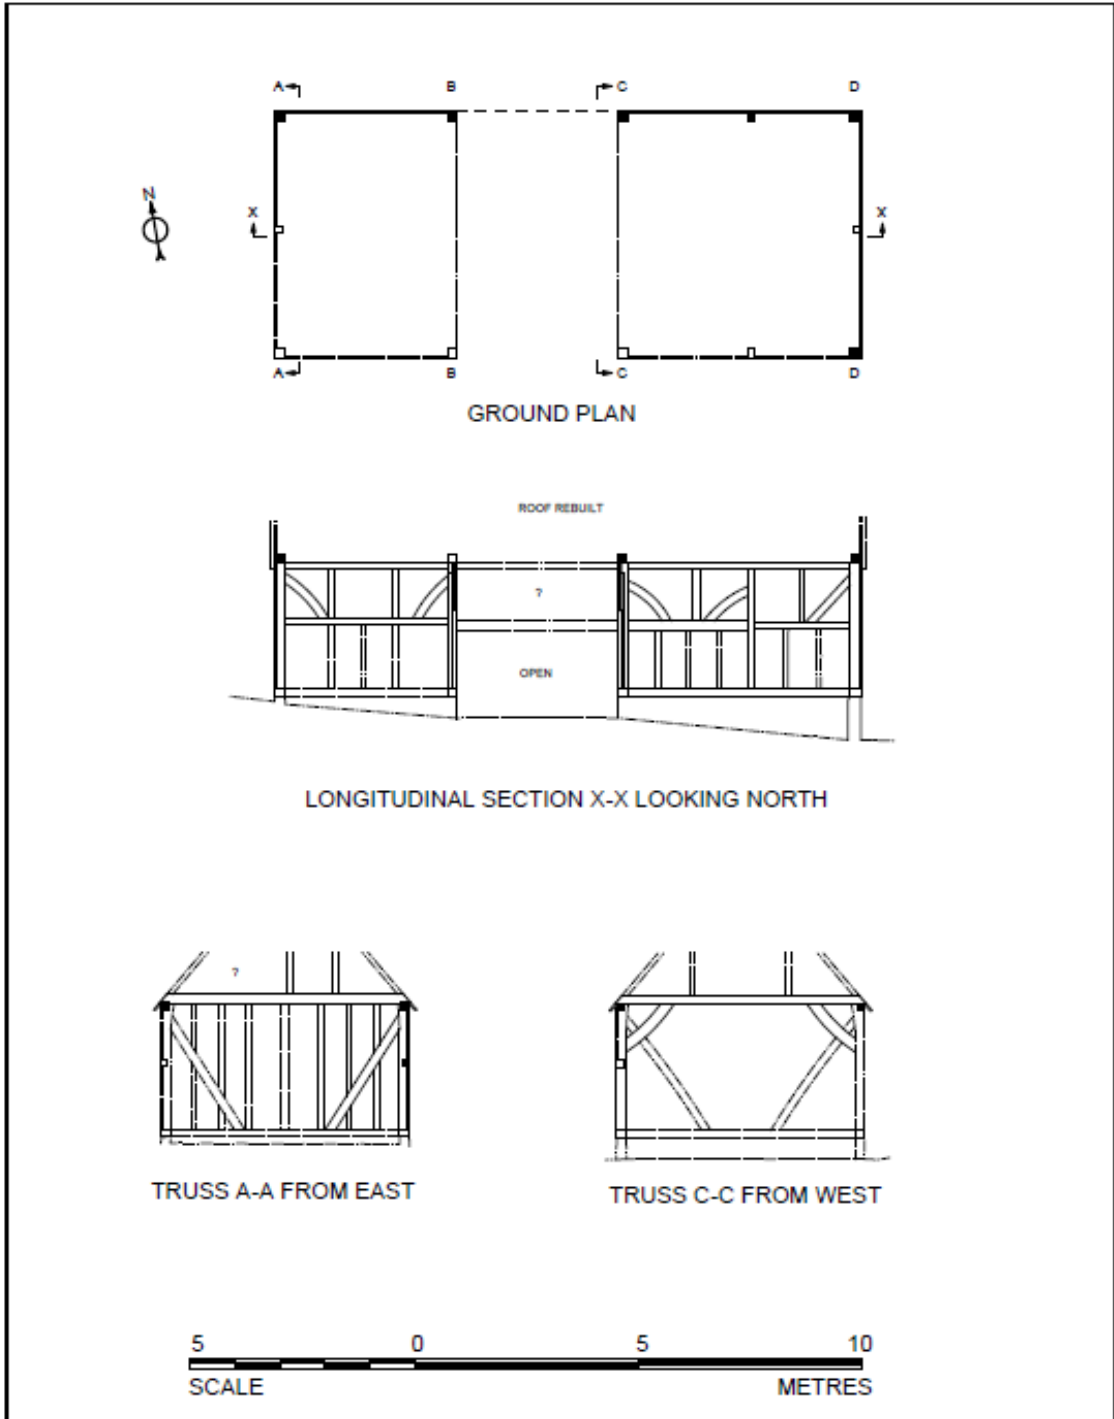
Fig.9 Long section, plan and cross sections

- 5.2.4 The post at truss C is 260mm wide and also has a sloping jowl has been compromised by the truncation of the top of this post to fit it into the frame height (plate 6 and 7). This truss has been recorded by a cross section drawing (fig.9).The brace has evidence for a removed shore, which was mirrored in truss B, which would have run diagonally down to the soleplate with a rail fixed between the shore in truss B and C in order to facilitate crop storage. This post in particular has been open to the elements for some time and has been subjected to fairly extensive weathering and is in a very poor condition. There is a convex curved head brace running to the tie-beam. Further mortices in the south face relate to a previous phase. The external face of this post was visible during a recent watching brief (Fisher, L 2015. A Watching Brief at Glebe Barn, Brightling. Project number ASL 45-14) which showed two further mortices cut into the east facing side.

- 5.3.3 The north elevation between truss A and B (plate 10 and 11) consists of re-used timbers of fairly thick scantlings at times with interrupted studs and curved braces 190mm wide which run from the wall plate to the side girt. This elevation has been recorded by a long section drawing (fig 9). The wall plate and the side girt have mortices cut into the soffits indicating the position of previous timbers and in particular, the wall plate has stave holes to the side of some of the mortices indicating a previous wattle and daub exterior which does not belong to this structure. The elevation between truss B and C houses the wagon way and between truss C and D (plate 12) a similar construction design utilizes older timbers of similar scantlings with interrupted studs and corner bracing but with an intermediate post approximately two thirds of the way across the bay to the east.

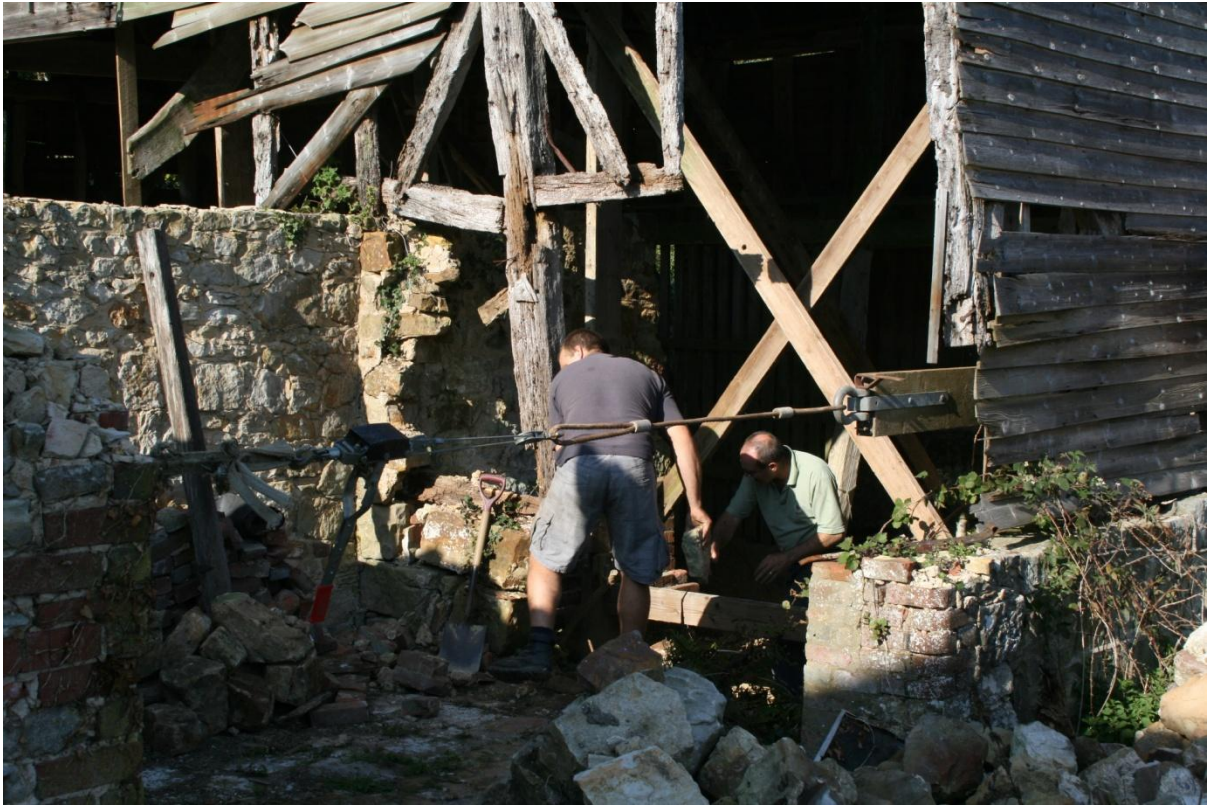
Plate 21 The client renovating the south east corner (Reproduced by kind permission of Jamie French)

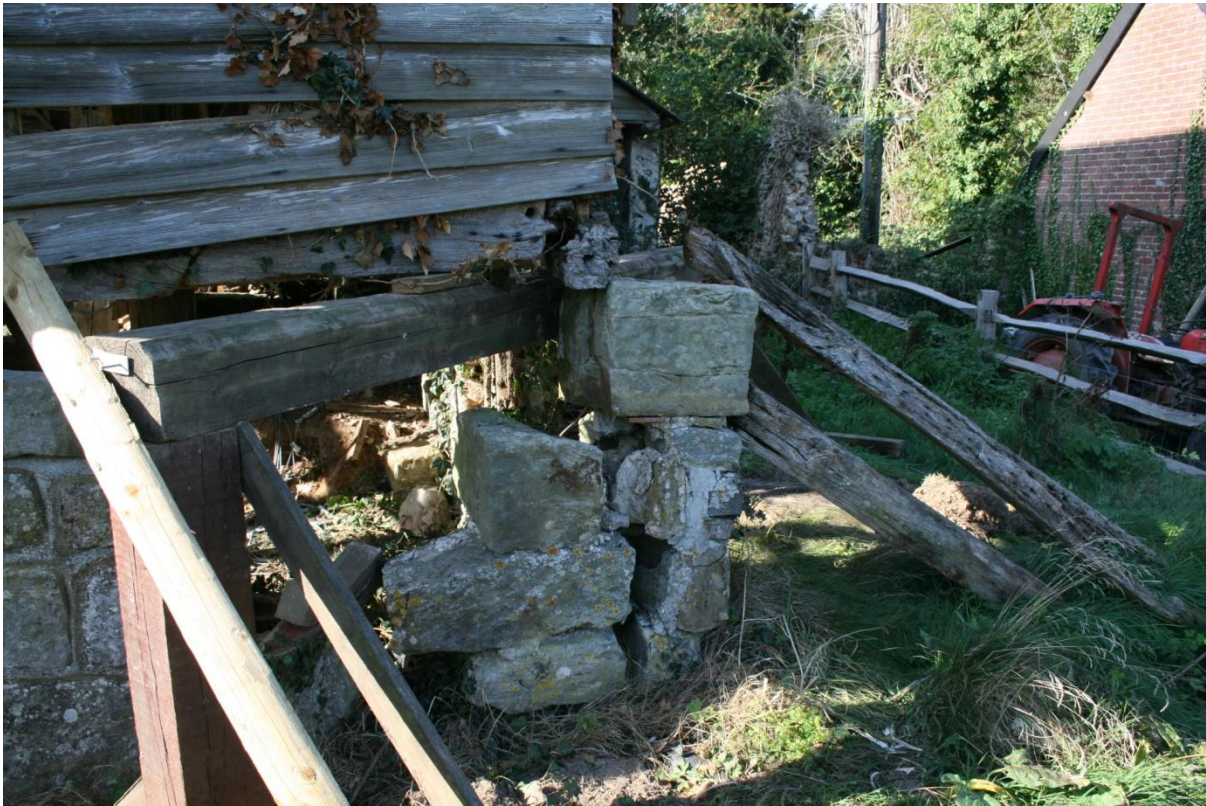
Plate 24 Before renovating the north east corner (Reproduced by kind permission of Jamie French)

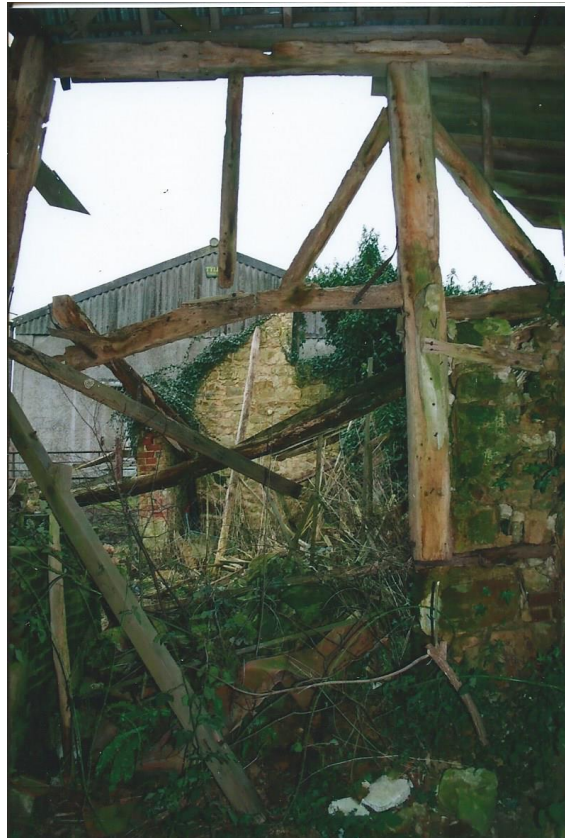
Plate 25 Before client renovating the south east corner (Reproduced by kind permission of Jamie French)
